2002 Annual Compliance Report Grand Junction, Colorado, Disposal Site

Compliance Summary

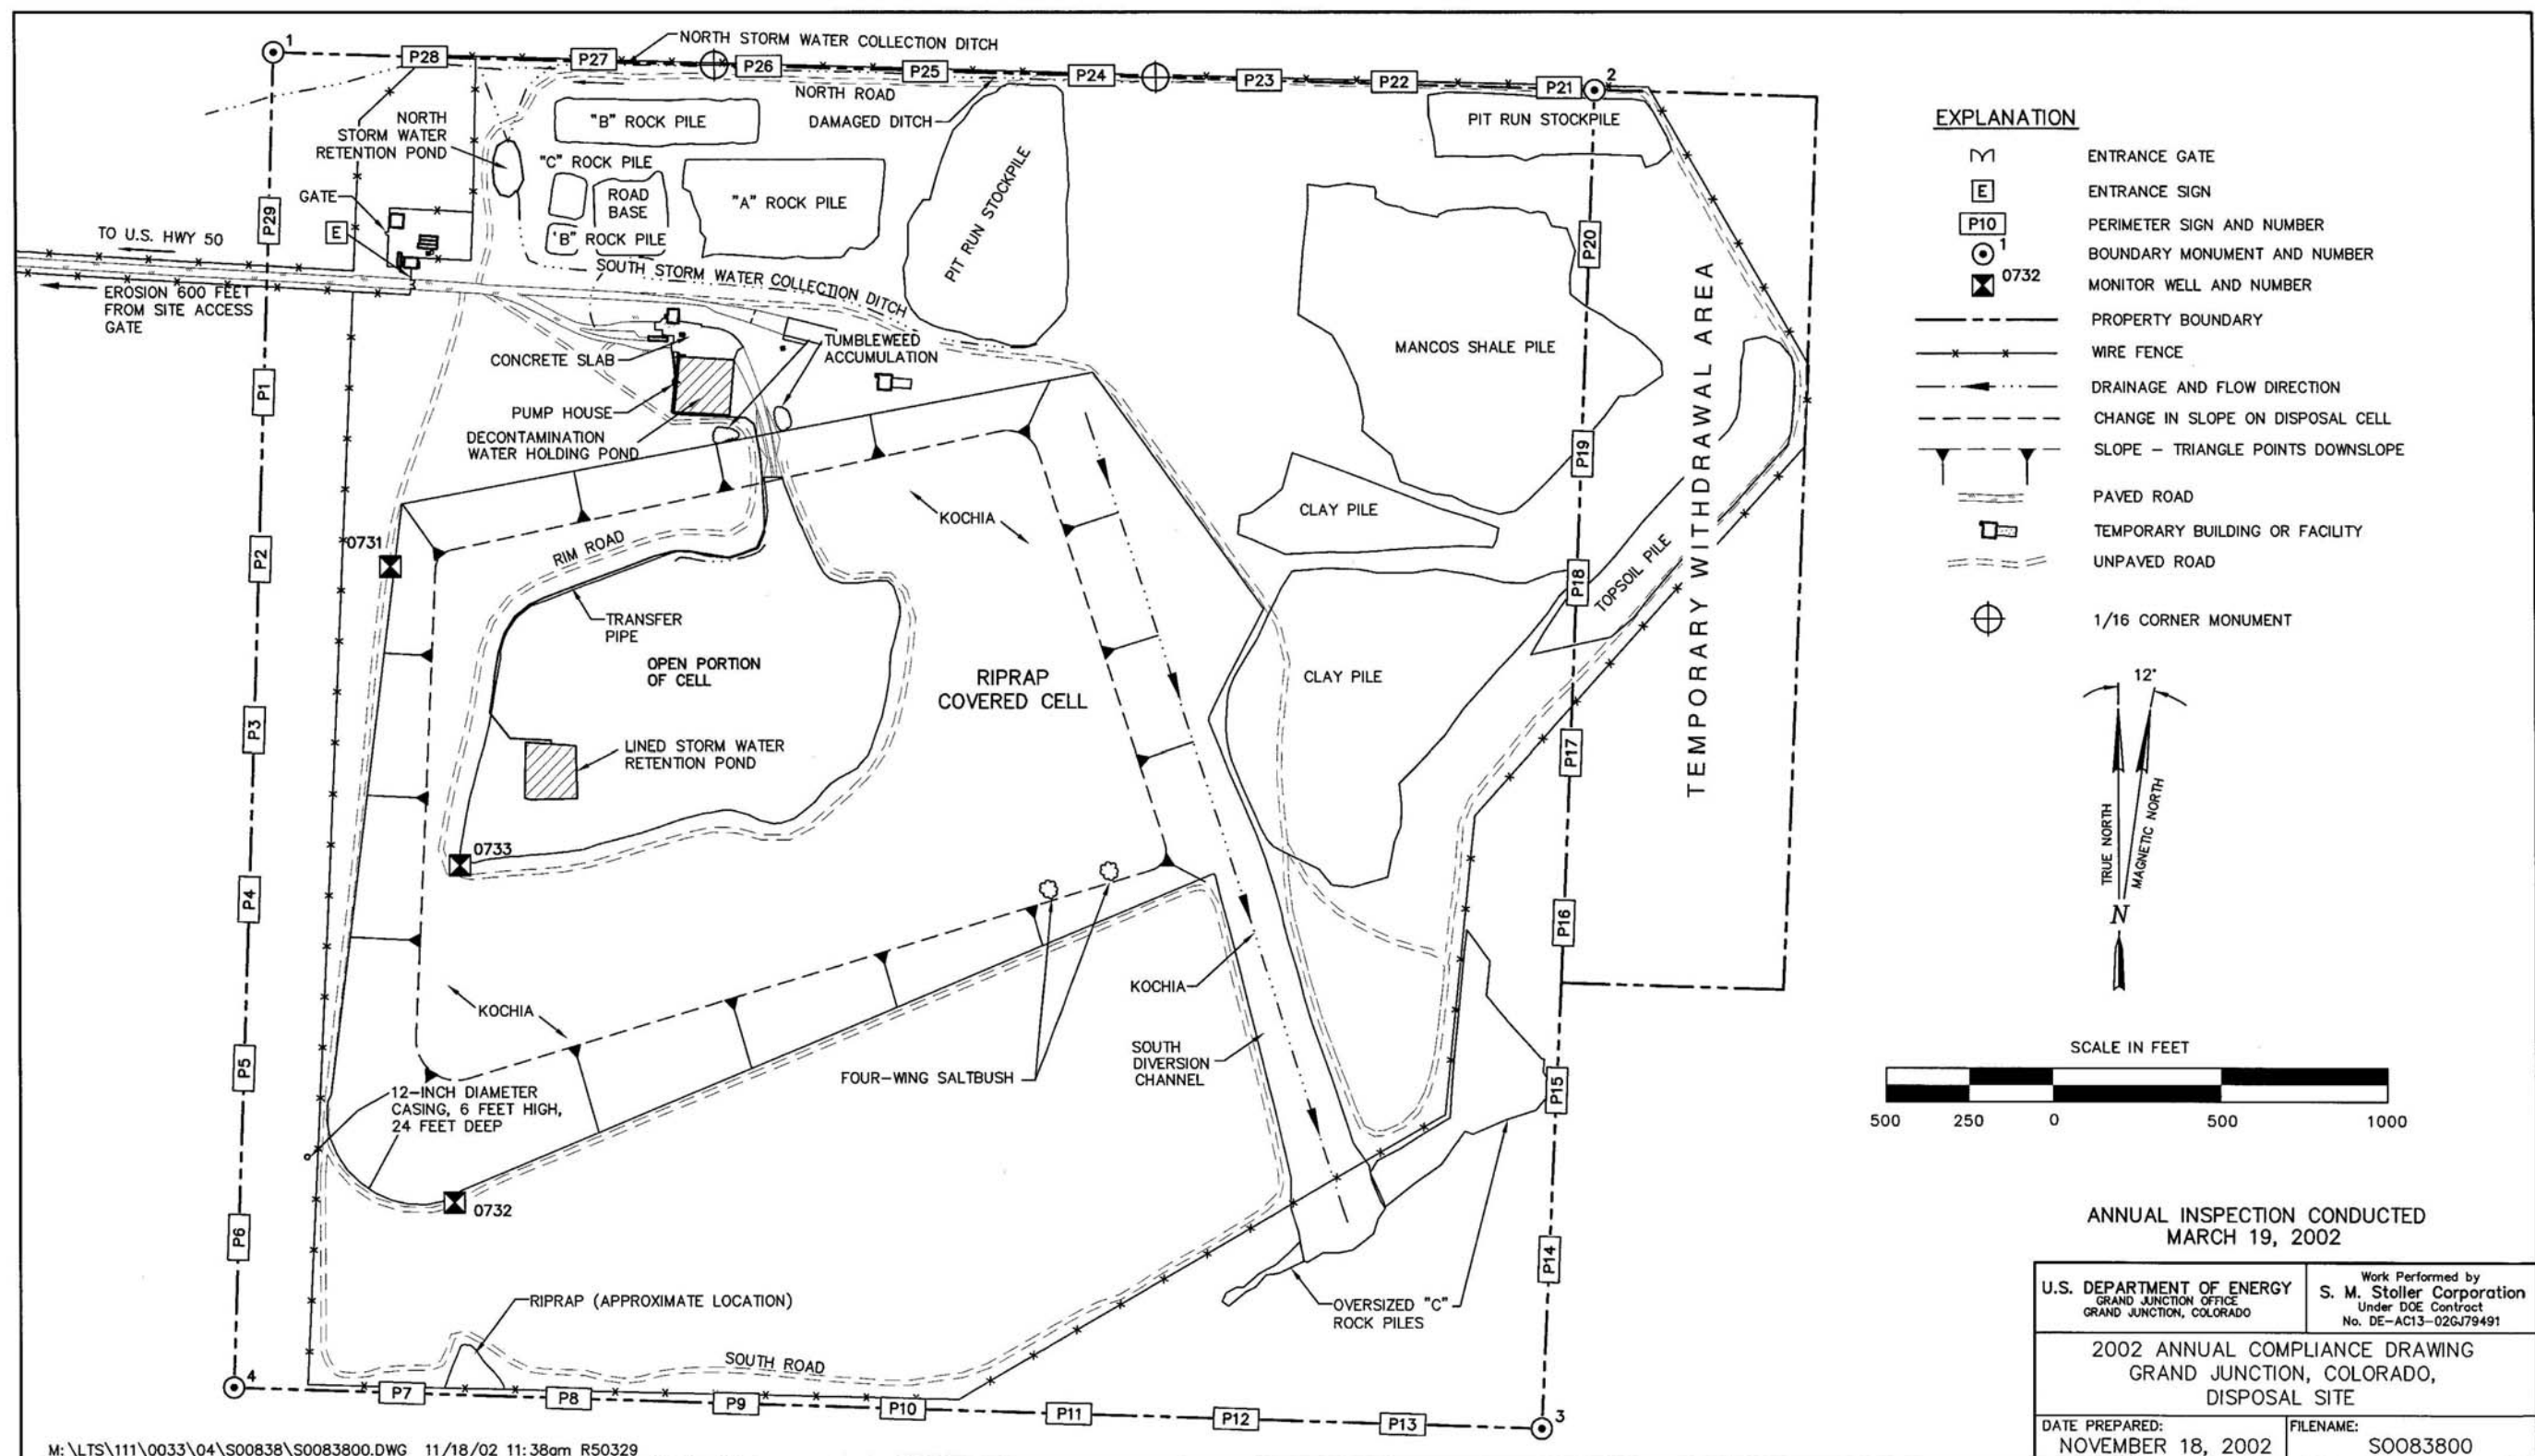
Figure 6-1. 2002 Annual Compliance Drawing for the Grand Junction, Colorado, Disposal Site

6A The drainage ditch along the south side of the access road discharges into an arroyo approximately 600 feet from the site access gate located on U.S. Highway 50. Erosion is occurring at the outfall of the drainage ditch. Because the erosion threatens the integrity of the access road, the outfall of the drainage ditch will be monitored and erosion control measures will be evaluated.

6B Additional warning signs are posted on the wire perimeter fence and are associated with the operation of the open cell. Metal "Controlled Area" signs and yellow plastic "No Trespassing" signs are secured to the fence in pairs. There are 75 warning sign locations, each about 200 feet apart along the site boundary. Loose metal signs were resecured and missing plastic signs were replaced with metal signs.

6C Plant encroachment is occurring, mostly on the southeastern part of the disposal cell top. Deep-rooted plants, which were cut back and treated with herbicide in 2001, may change the performance characteristics of the radon/infiltration barrier. This condition needs to be evaluated as part of the work underway by the DOE Long-Term Performance and Cover Monitoring Project to determine if control of these plants is necessary. Until the evaluation is completed, these plants will be controlled. The disposal cell cover will continue to be monitored for plant encroachment; however, no additional plant control was required in 2002.

6D Other drainage features at the site include north and south storm water collection ditches and a storm water retention pond. These features are along the northern edge of the disposal site. The ditches are small and unimproved. The north storm water collection ditch captures runoff from a large catchment area north and east of the disposal site. Water captured in this ditch flows into a large natural drainage north and west of the disposal cell. Minor erosion was previously noted west of the perimeter fence where the north storm water collection ditch ends and water spills down slope into the natural drainage northwest of the disposal site. Erosion did not appear to have occurred since the last inspection; however, the outflow area below the mouth of the north storm water collection ditch should continue to be monitored. The north road crosses the north storm water collection ditch between signs perimeter signs P24 and P25. Tire ruts have caused water to leave the collection ditch and flow down the road. The ditch will be reconstructed at the vehicle crossing in 2003. The south storm water collection ditch collects onsite storm water from the cover material stockpile areas and other places across the northern part of the site. This ditch flows west into the north storm water retention pond. A second ditch flows south into the north storm water retention pond. Both ditches are small and are filling with sediment and weeds. Inspectors noted that the ditches showed signs of having conveyed water without overtopping. The ditches did not need maintenance, but at some point they may need to be cleaned out to convey storm water.

Warning signs on the perimeter fence were resecured or replaced as needed.

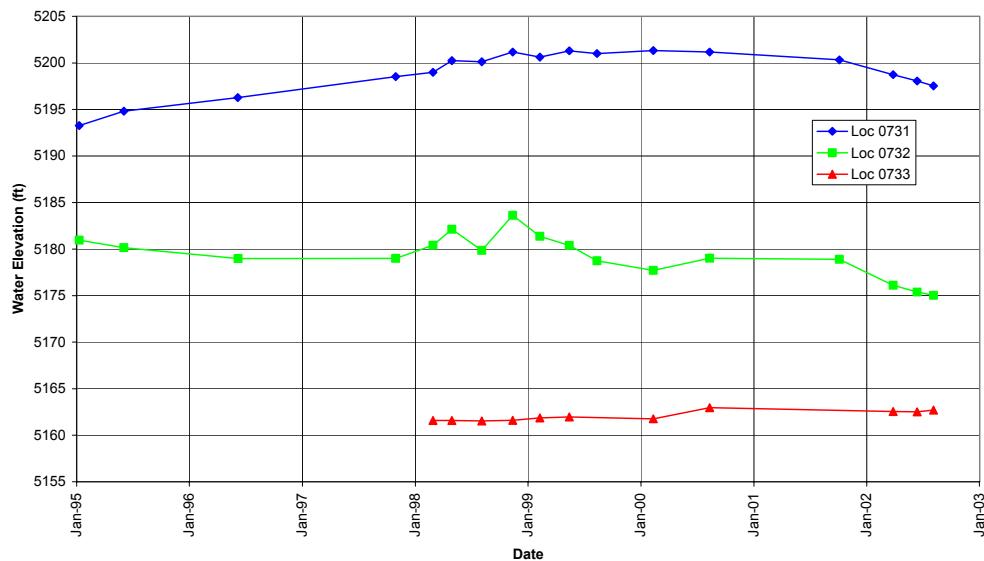
Figure 6-2. Water Level Measurements at the Grand Junction, Colorado, Disposal Site

In lieu of monitoring ground water in the uppermost aquifer, ground water in two monitor wells in or very near buried paleochannels adjacent to the disposal cell (0731 and 0732) and one monitor well in the disposal cell (0733) is monitored to assess performance of the disposal cell and to ensure that any water in the paleochannels is not impacted by seepage from the disposal cell (Figure 6-1). The paleochannel wells are located along the west (downgradient) edge of the disposal cell and are screened at the interface between the alluvium and shallow Mancos Shale. The third well is in the southwest corner of the open portion of the disposal cell and is used primarily for measurement of water levels in the deepest part of the disposal cell to demonstrate that intracell water will not rise high enough to move laterally into the paleochannels. The water level in the disposal cell well (0733) is approximately 15 and 35 feet lower (deeper) than water levels in the paleochannels at wells 0731 and 0732, respectively (Figure 6-2). This indicates that ground water cannot seep from the disposal cell to the paleochannels. The disposal cell is designed to shed rainfall and snowmelt efficiently; therefore, variable water levels in the paleochannel wells could be attributed to increased runoff from the cell.

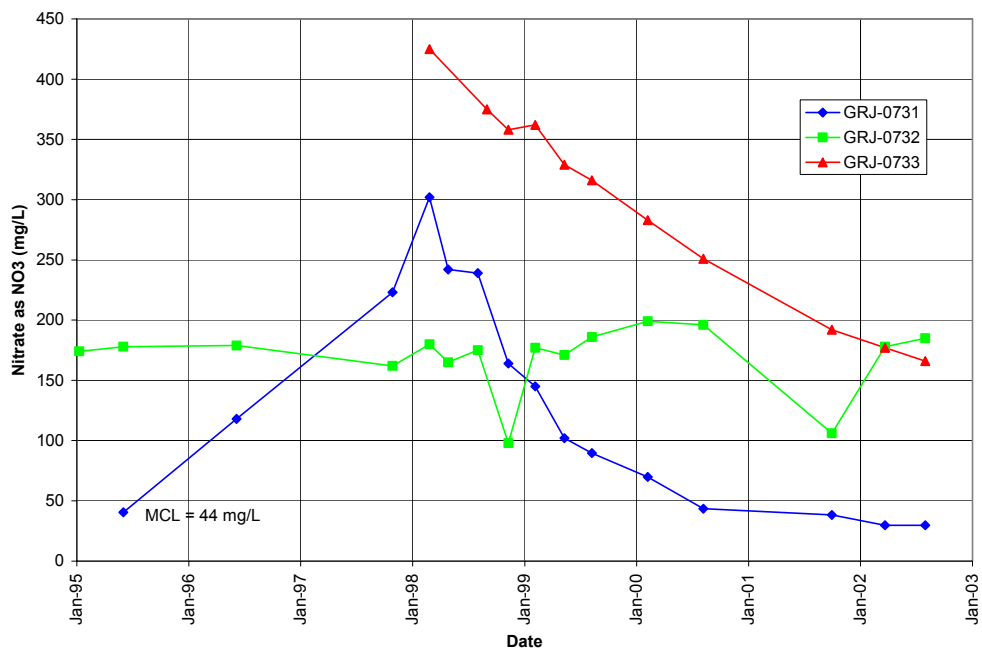
Figure 6-3. Time-Concentration Plots of Nitrate (as NO₃) in Ground Water at the Grand Junction, Colorado, Disposal Site

Results from sampling in 2002 were consistent with results from the past several years. Molybdenum and vanadium concentrations in ground water continued to be near or below the required laboratory detection limits and significantly below the MCL or risk-based standard at all wells. Nitrate concentrations exceeded the MCL of 44 mg/L in wells 0732 and 0733, but were below the MCL in well 0731 (Figure 6-3). Selenium levels continued to exceed the MCL of 0.01 mg/L at both downgradient wells and remained below the standard at monitor well 0733 (Figure 6-4). Sulfate concentrations continued to be relatively high in all wells, at approximately 6,500 mg/L in the disposal cell, and just below 4,000 mg/L in the paleochannel wells. High sulfate concentrations are typical of the regional soils, which contain gypsum. Concentrations of TDS continued above 10,000 mg/L in well 0733 in the disposal cell. Concentrations of TDS in ground water in the paleochannel wells were around 7,000 mg/L. Uranium concentrations in ground water remained approximately at the MCL of 0.044 mg/L in well 0731, but below the MCL in wells 0732 and 0733 (Figure 6-5).

Nitrate, selenium, sulfate, TDS, and uranium concentrations in ground water in monitor well 0731 peaked around 1998 and have declined steadily since then. A possible explanation for this decline is the disturbance of the paleochannel near monitor well 0731, which may have exposed native material to ground water. In comparison, concentrations at monitor well 0732, where the paleochannel was not disturbed, remain generally constant. Sampling in 2002 indicated no significant departures from analytical results of previous years.

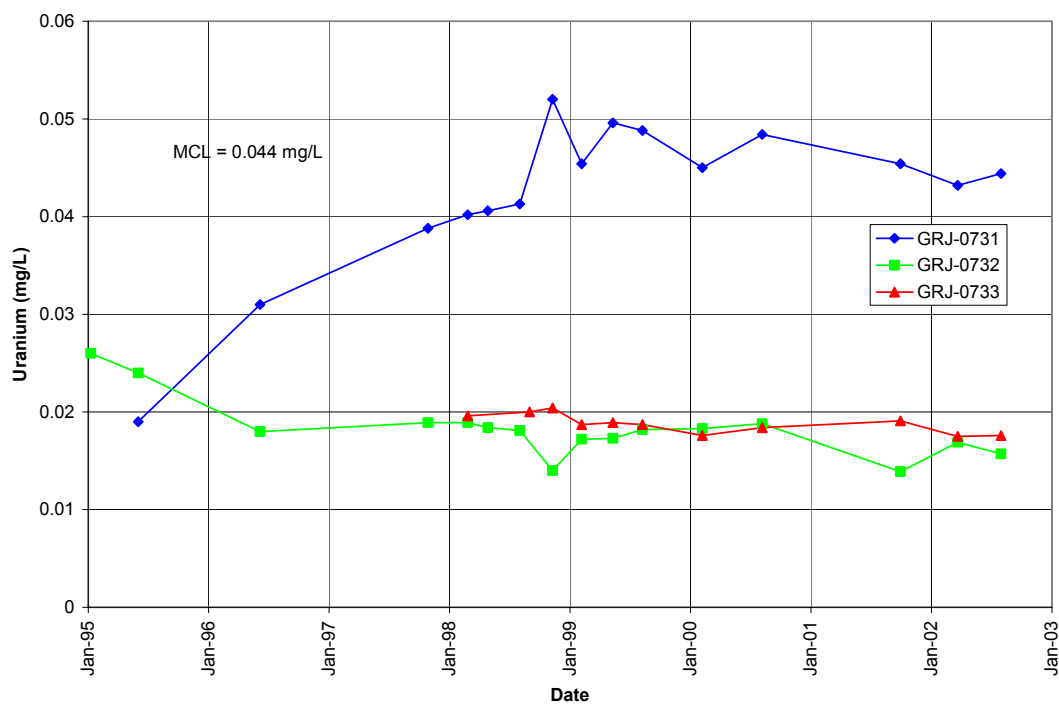
Figure 6-5. Time-Concentration Plots of Uranium in Ground Water at the Grand Junction, Colorado, Disposal Site

Elevated levels of nitrate, sulfate, and uranium in ground water in the paleochannels are most likely due to leaching of natural soils and weathered shale around the paleochannels. Increased runoff from the cell may have increased moisture in soils, paleochannels, and weathered shale around the disposal cell, which would increase the mobility of nitrate, sulfate, and uranium in these materials.
